**Assure Roof Surveys**  
ROA: 5 South Charlotte Street  
Edinburgh, EH2 4AN

## Overview of Findings – Visual Survey

Survey Date:  
25.02.2026

| <b>Property Roof Description:</b> | <p>The property is a domestic dwelling dating from 1629, subdivided into upper and lower flats. The original slate roof was replaced circa 1970.</p> <p>The roof comprises a pitched main roof with a small lean-to roof to the rear, finished in slate, and features a crow-stepped gable end.</p> <p>A visual inspection was undertaken to assess the condition of the roof and identify any required remedial works.</p> |

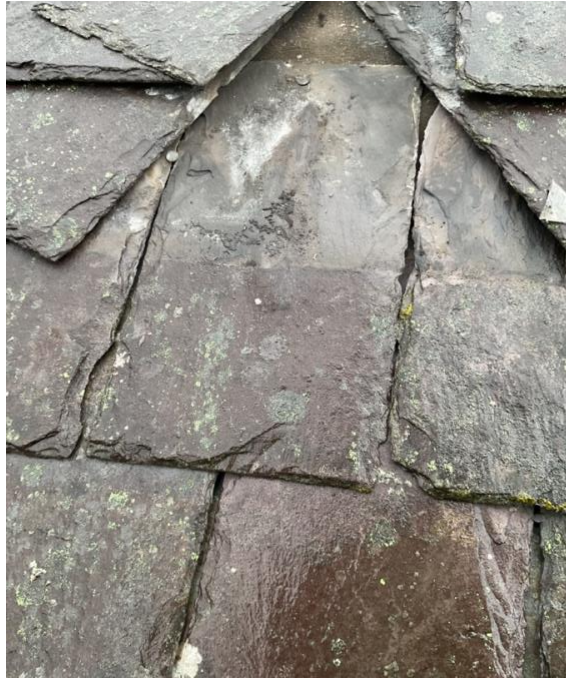
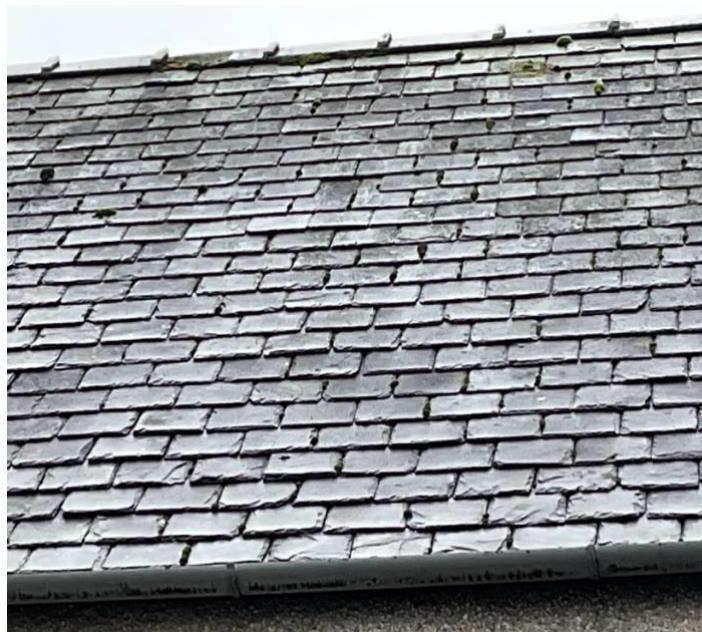
### Roof Coverings (Slate)

| | Findings & Implications | Recommendations |
|---|---|---|
| <b>Slates Roofs</b> | <p>The main roof covering is in good overall condition, comprising of Welsh slates fixed with single galvanised clout nails, with additional cheek nails provided at every third course. The slates are laid over Type 1F felt and have been installed to a good standard.</p> <p>Aside from a small number of missing slates, particularly at the rear right-hand side adjacent to the chimney, the overall condition of the slate covering is good.</p> | 1 . Replace missing and broken slates with matching Welsh slates. |

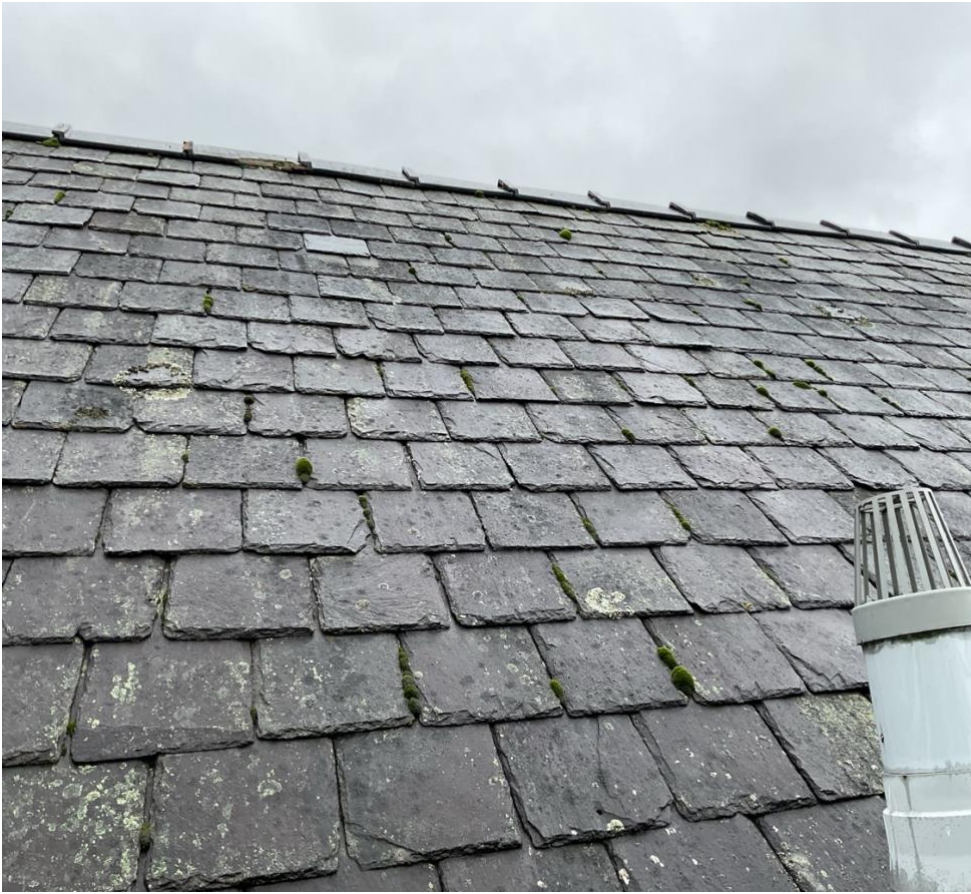
## Ridge Coverings

| | Findings & Implications | Recommendations |
|---|---|---|
| <b>Ridge Coverings</b> | The roof has capped angled ridges bedded on sand and cement. Ridges are generally in good condition, with the exception of one ridge tile that requires replaced. | 2. It is recommended that the broken ridge is replaced like-for-like. |

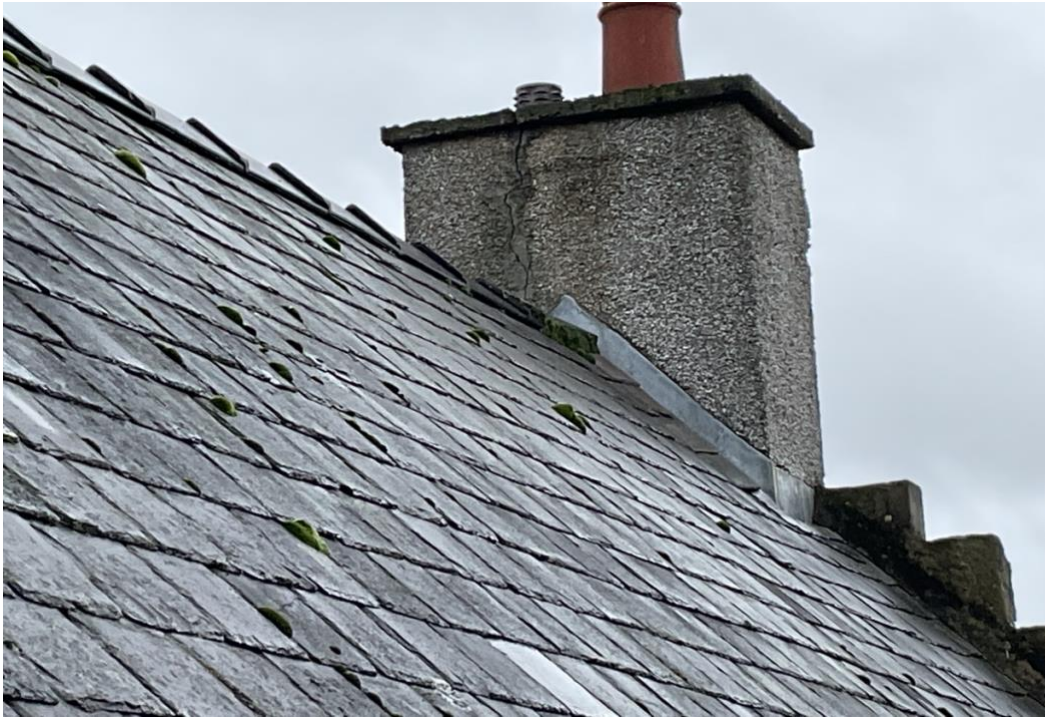
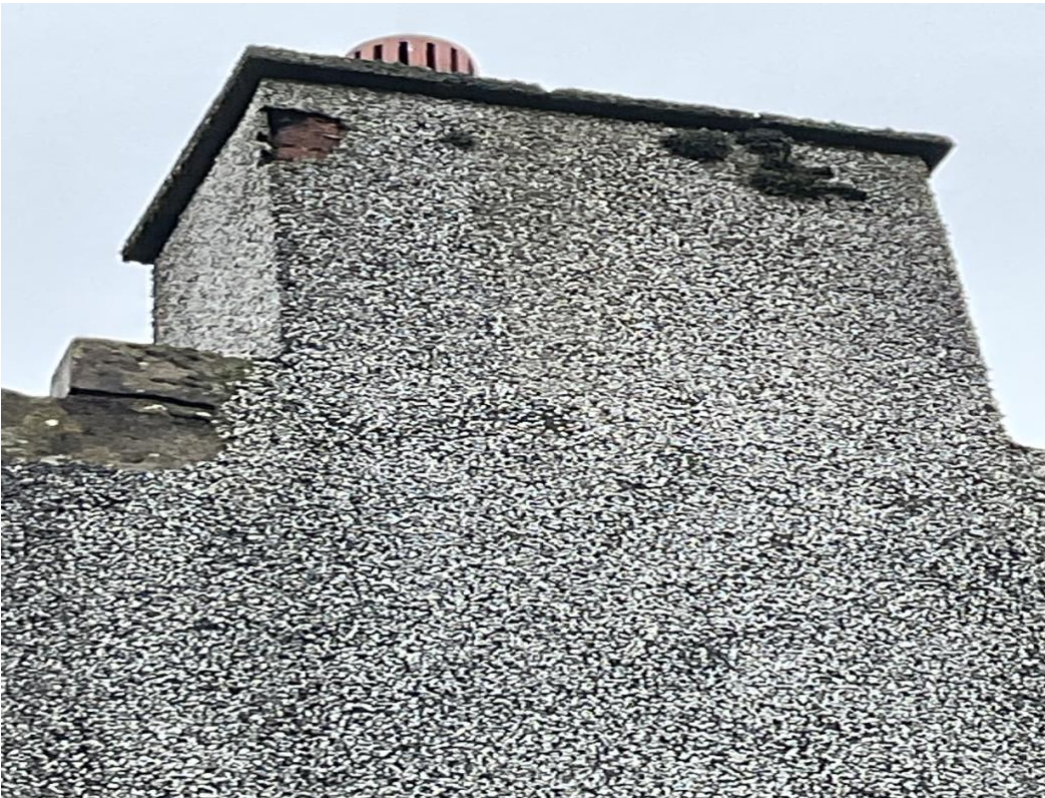
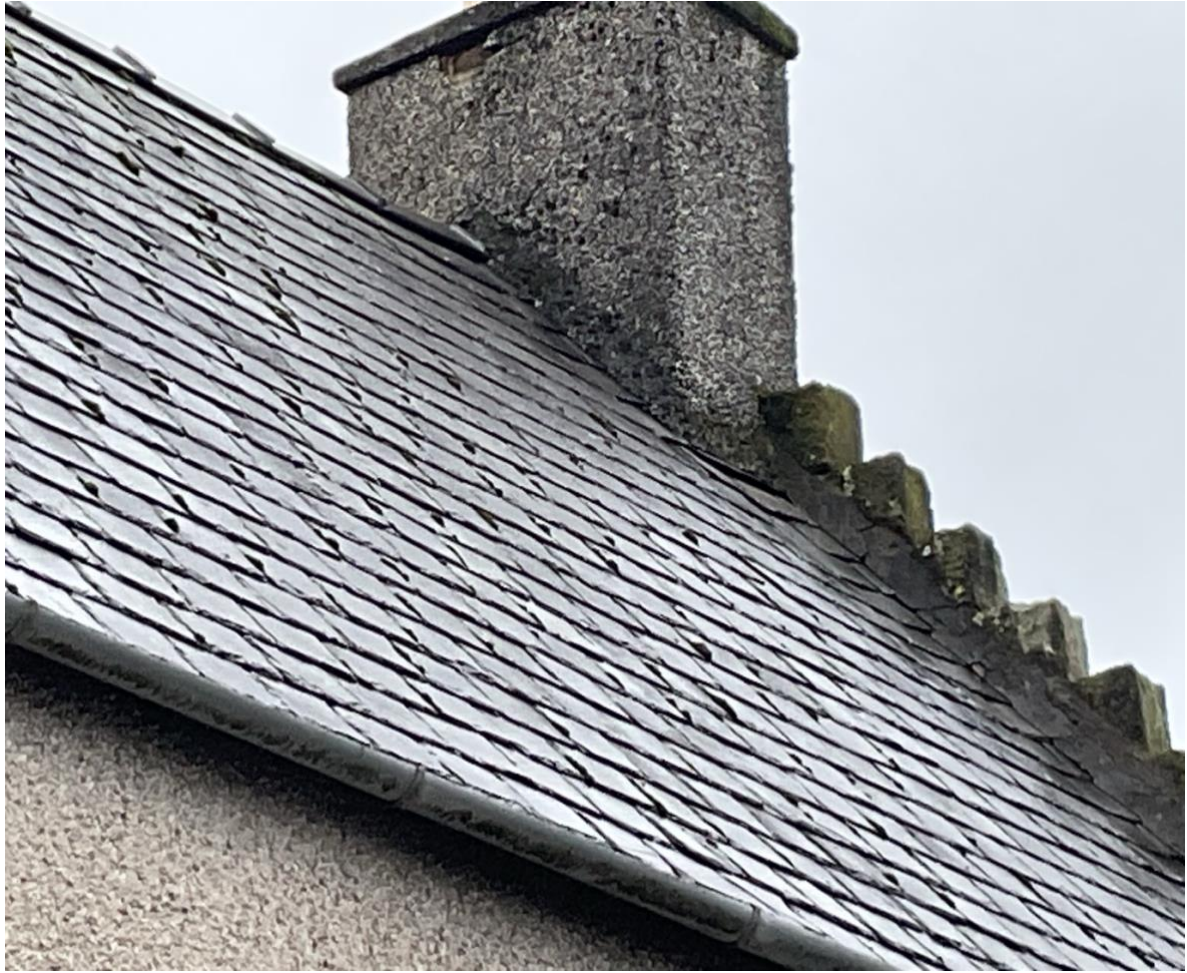
## Chimney Stacks

| | Findings & Implications | Recommendations |
|---|---|---|
| <b>Chimney stacks</b> | Both chimneys show signs of deterioration, including cracks and areas of missing roughcast. | 3. Roughcasting contractor remove damaged render and repairs it to match the existing finish. |

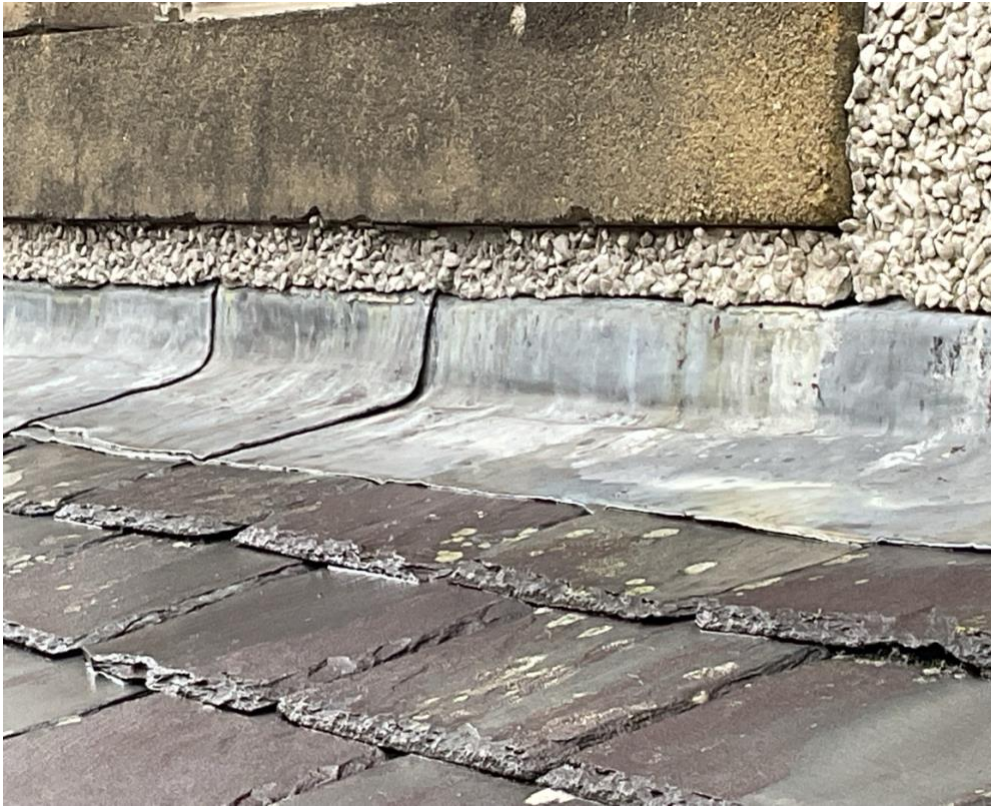
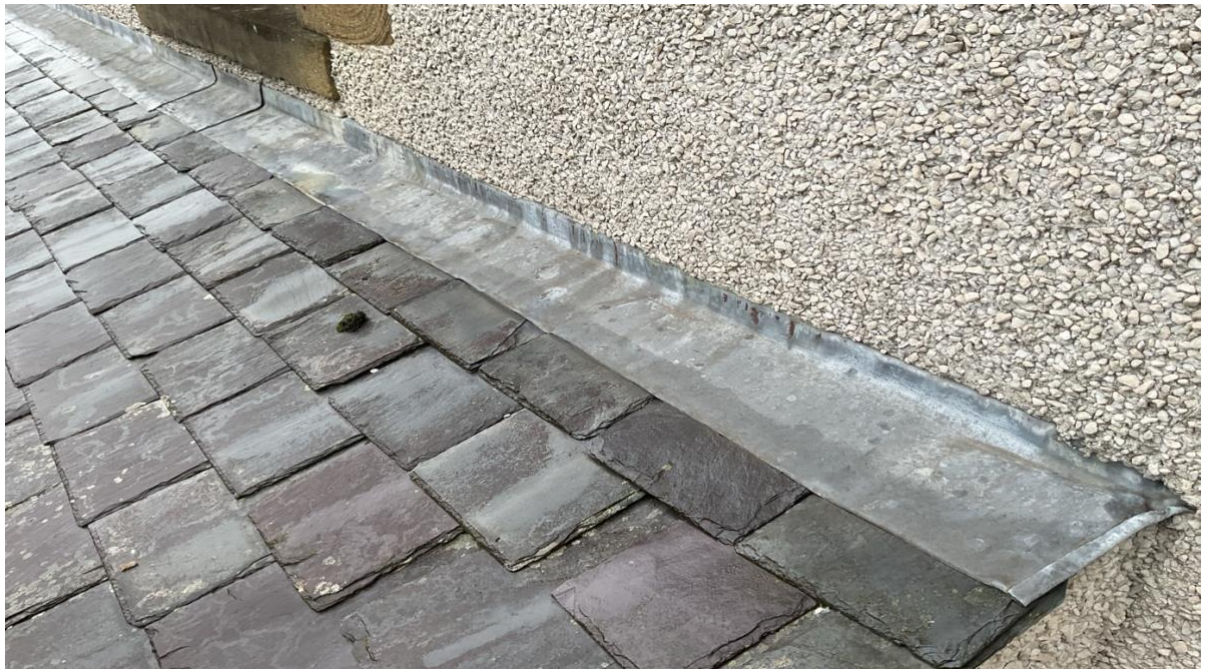
## Mortar / Lead Flashings

| | Findings & Implications | Recommendations |
|---|---|---|
| <b>Mortar / Lead Flashing</b> | <p>The lead flashing around the front right-hand chimney is in good condition and requires no action at this time.</p> <p>The lead flashing to the rear kitchen roof has been installed in longer</p> | 4. Gap to be sealed using a lead-compatible sealant e.g. lead-mate. |

| | lengths than recommended, which can increase the risk of cracking and tearing over time due to natural expansion and contraction. This movement has caused the flashing to pull slightly away at the lower edge, creating a fine hairline gap that could allow water to enter. | 5. Monitor flashing for future cracking which may take many years to develop. |

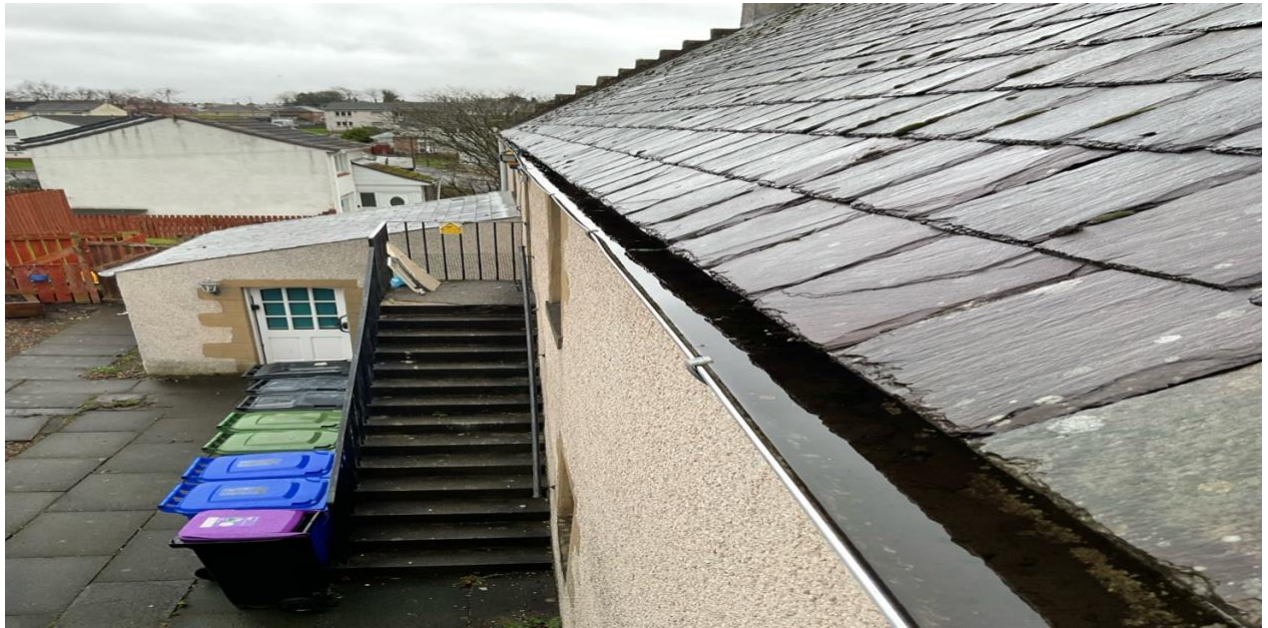
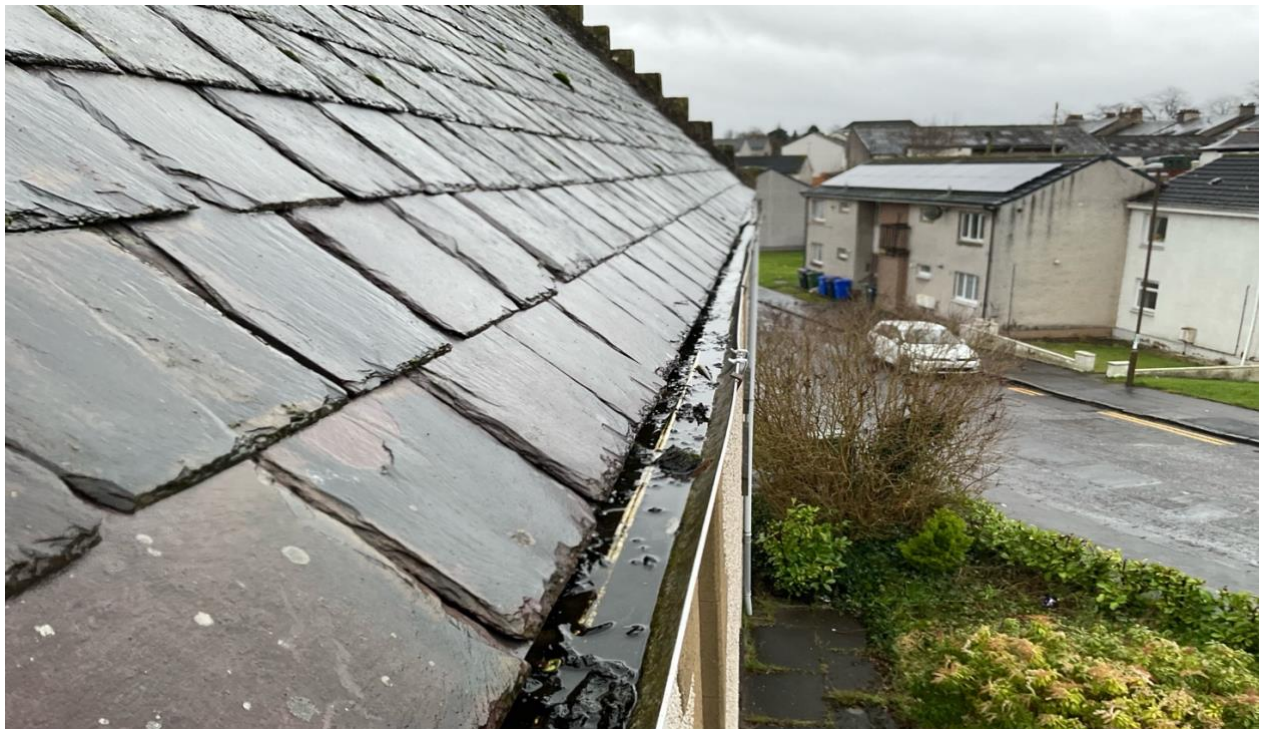
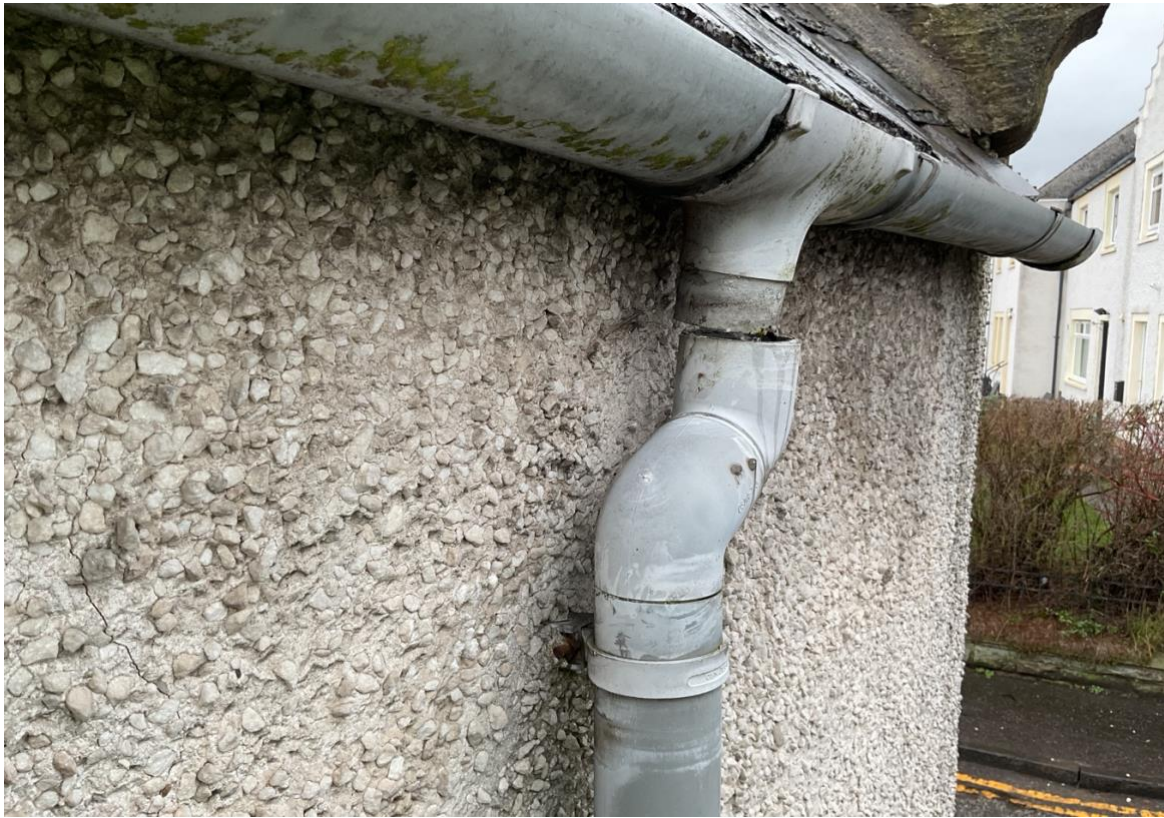
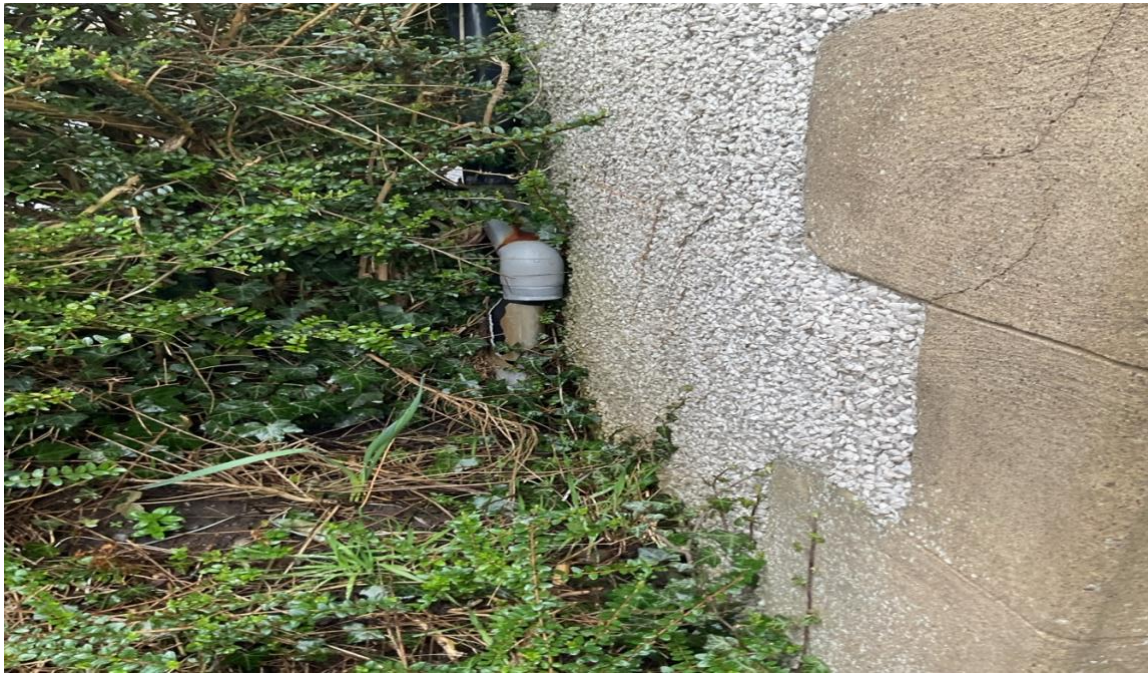
## Rainwater Systems / Gutters and Downpipes

| <b>Rainwater Systems / Gutters / Downpipes</b> | <p>Half-round plastic gutters are fitted to both sides of the roof and are supported by metal top-rafter brackets.</p> <p>The gutters contain standing water and debris and are not draining freely. No leaks were observed at the joints, and the gutter brackets remain generally sound with no significant corrosion.</p> <p>The rear gutter is disconnected from the downpipe, and the front downpipe is broken at ground level.</p> | <p>6. Replace front downpipe</p> <p>7. Rear downpipe re-connected</p> <p>8. All gutters cleared of debris</p> <p>9. Thereafter gutters to be checked to ensure they fall correctly and realigned if necessary to allow proper drainage.</p> |

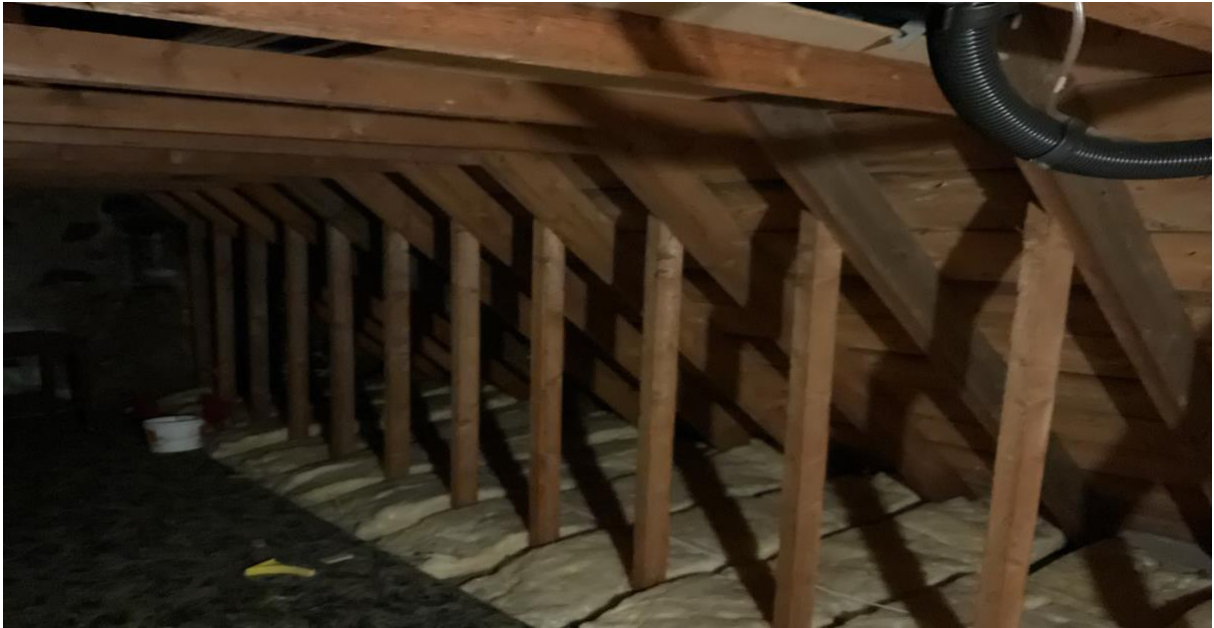
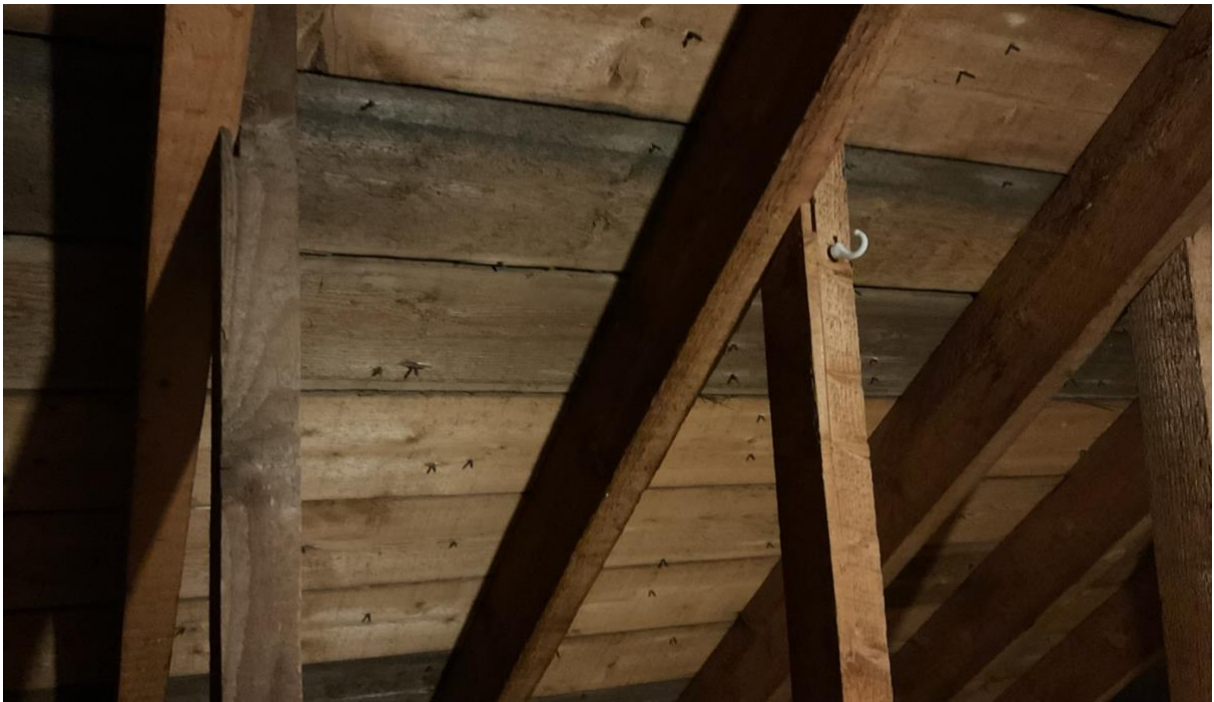
## Internal Loft Spaces

| <b>Internal Loft Spaces</b> | The internal loft space was found to be clear, with no signs of rot or water penetration. | |

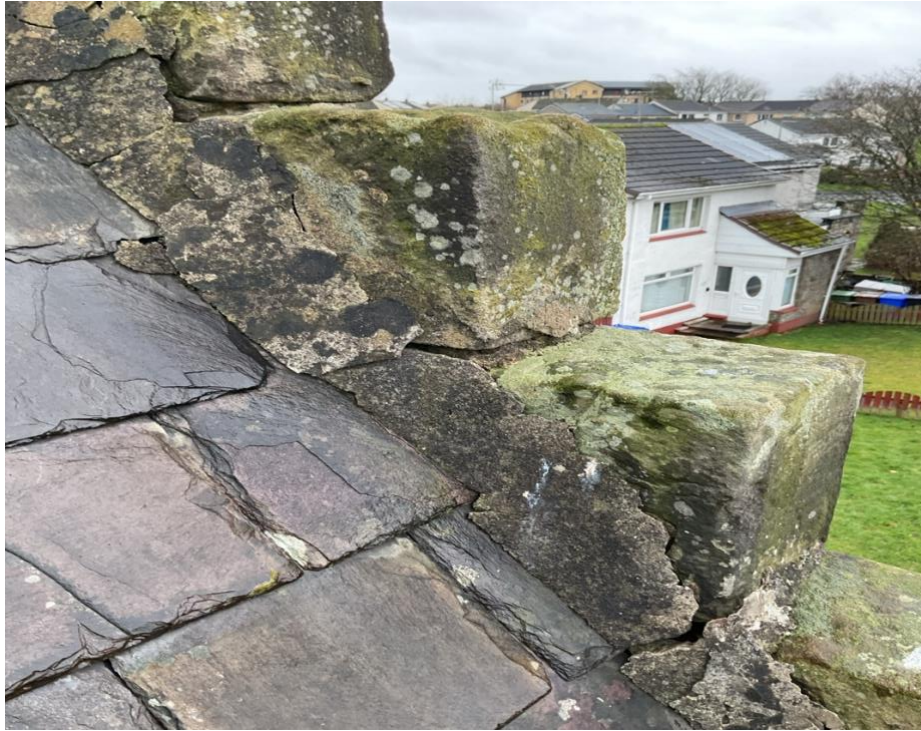
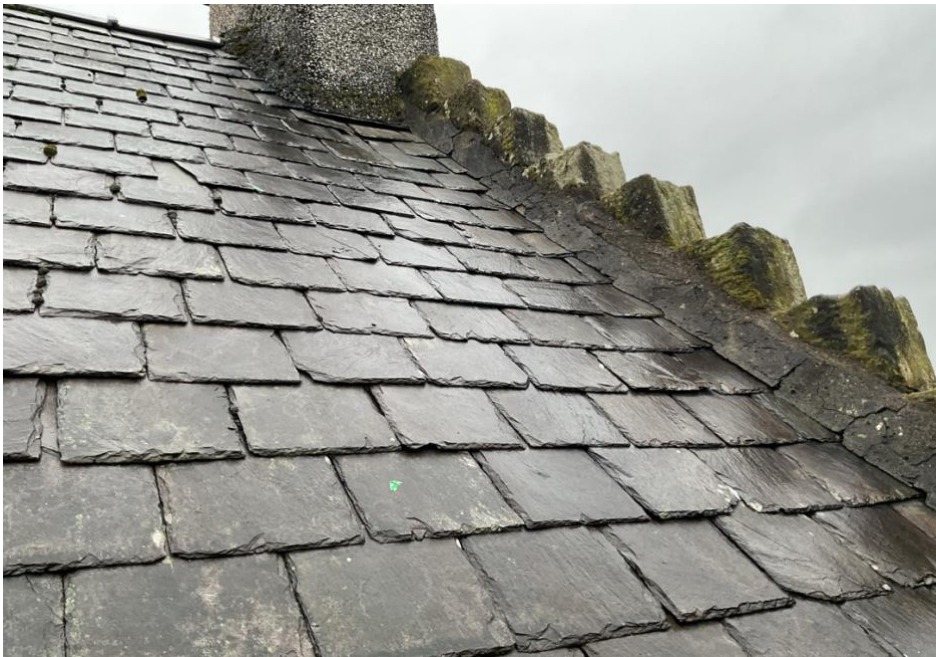
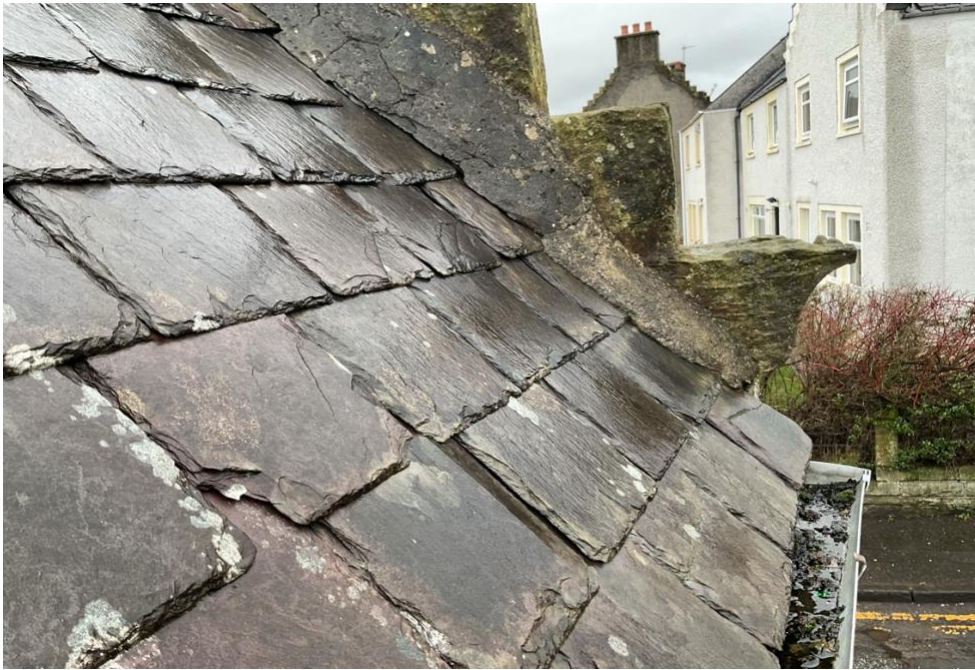
## Verges

| <b>Verges</b> | The crow-stepped gable end shows signs of deterioration, with areas of missing mortar. | 10. Mortar to be replaced using a lime mortar mix |
