# Independent Roof Survey Report

| <b>Property Roof Description:</b> | The family home at                      occupies the upper floor of a three-storey apartment building in the                      area of Glasgow, built in the early 1900s. The pitched roof is covered with modern concrete tiles and bay windows are natural slate covered. |
| <b>Survey Type:</b> | UAV (Drone) Survey |

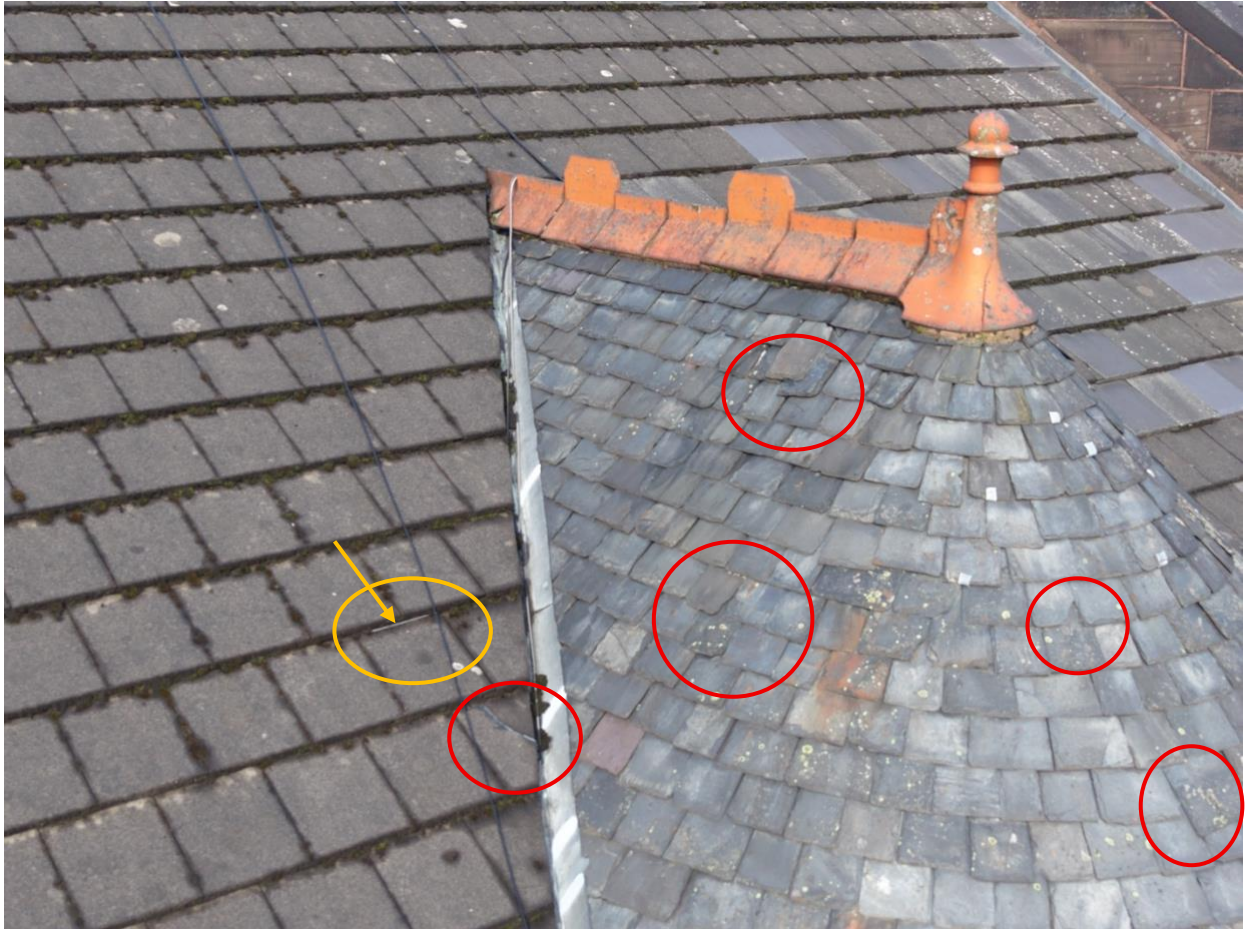
### Image 1 (Right bay window, left side)

Four slates at the bay window were observed to be cracked or missing, along with one broken concrete tile on the main roof. In addition, an unidentified object or possible historic repair was noted beneath a concrete tile, as highlighted in orange.

| | Findings & Implications | Recommendations |
|---|---|---|
| <b>Slates Roofs<br/>(bay windows)</b> | <p>Missing and slipped slates are noted to both bay window roofs as highlighted in images 1,3 and 4 above.</p> <p>The client reports ongoing issue with water ingress into the property.</p> <p>It is the opinion of the writer that it reasonable to assume that these missing and slipped slates are (in the absence of other issues) likely points of water penetration into the home around the area of the bay window.</p> <p>On cross-comparison and analysis of photographs taken and reported by _____, the writer can confidently state that no rectification work has taken place to the slated bay windows, which could have sustained damaged during storm _____. Repairs to bay window slates following the storm event would have likely addressed water ingress issues at the time.</p> | <p>Replace all broken and missing slate with matching.</p> |

| <b>Tile Roofs<br/>(main pitched roof)</b> | <p>As highlighted in images 1 and 2 above, there is a single broken concrete roof tile to right bay window; left side (shown in orange) which appears to have been repaired with silicone.</p> <p>There is a further broken tile in line with the previous tile, approximately 1.5m below ridge.</p> <p>As there is an ongoing issue with water ingress into the living room, it would be reasonable to assume that may also present a point of water ingress and therefore should be replaced during future rectification work.</p> | Replace broken concrete tiles with an exact brand and colour match, where this can be sourced. |

| <b>Overview of Recommendations</b> | <ol style="list-style-type: none"> <li>1. Replace all broken and slipped slates on both bay windows.</li> <li>2. Replace broken concrete tiles on main roof with exact same brand and colour where these can be sourced (or suitable alternative)</li> </ol> |

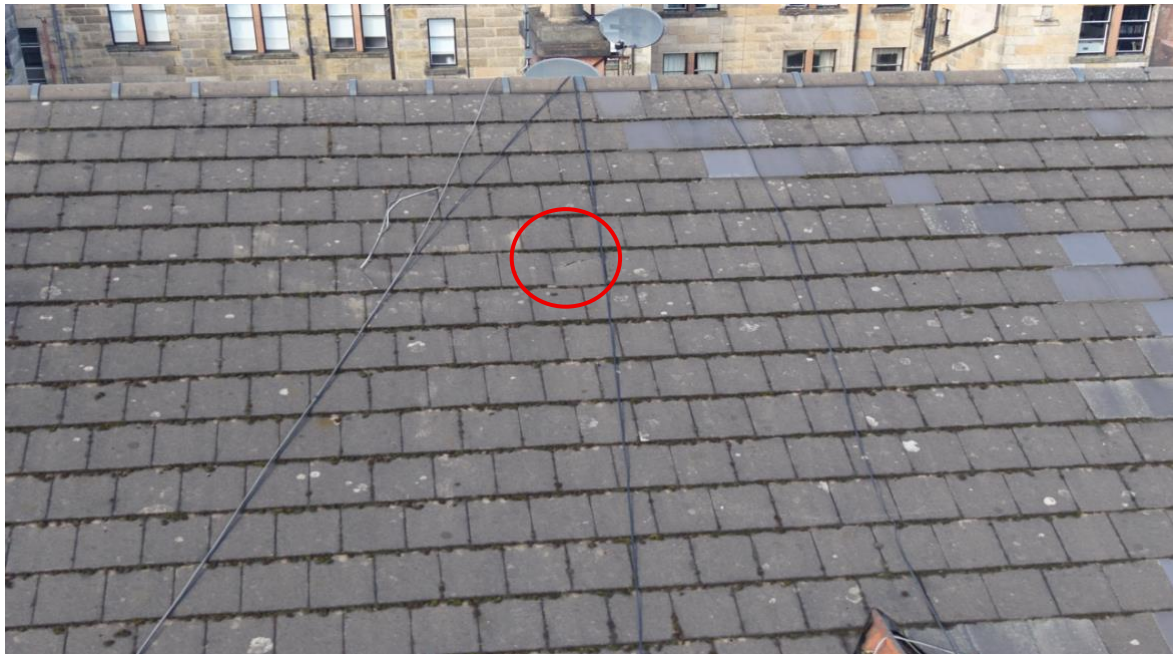
**Image 2 (Main pitched roof above right bay window)**  
Cracked concrete tile.

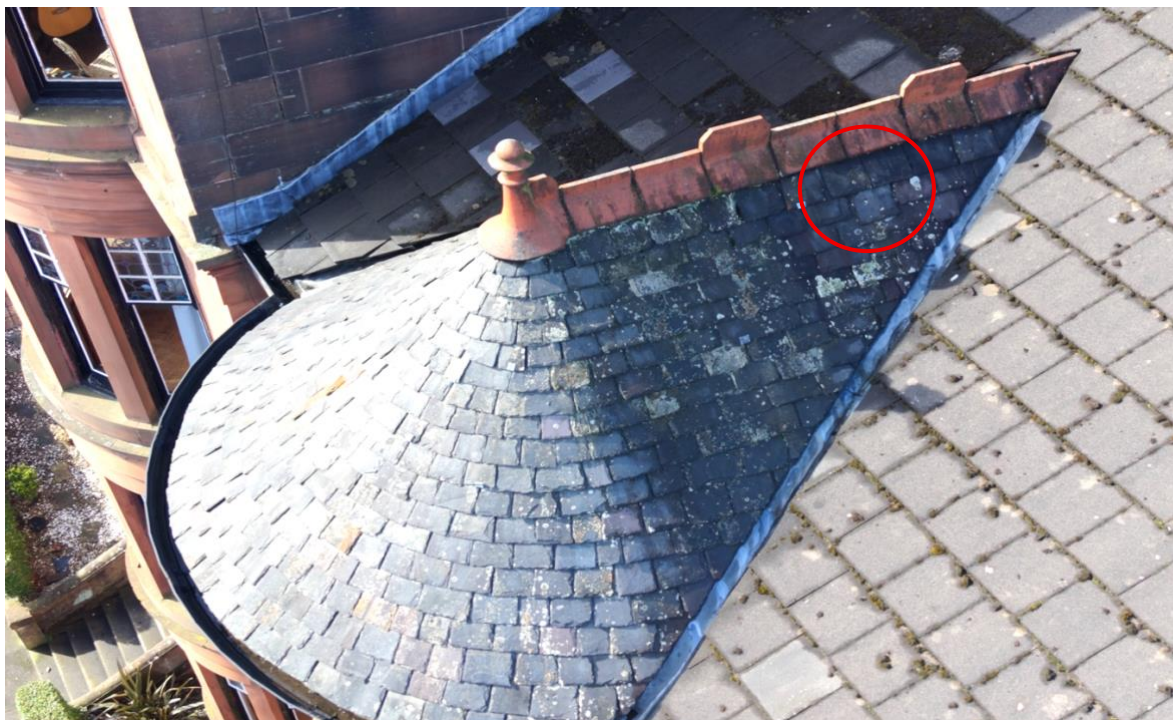
**Image 3 (Left bay window, right side)**  
Image shows slipped slate

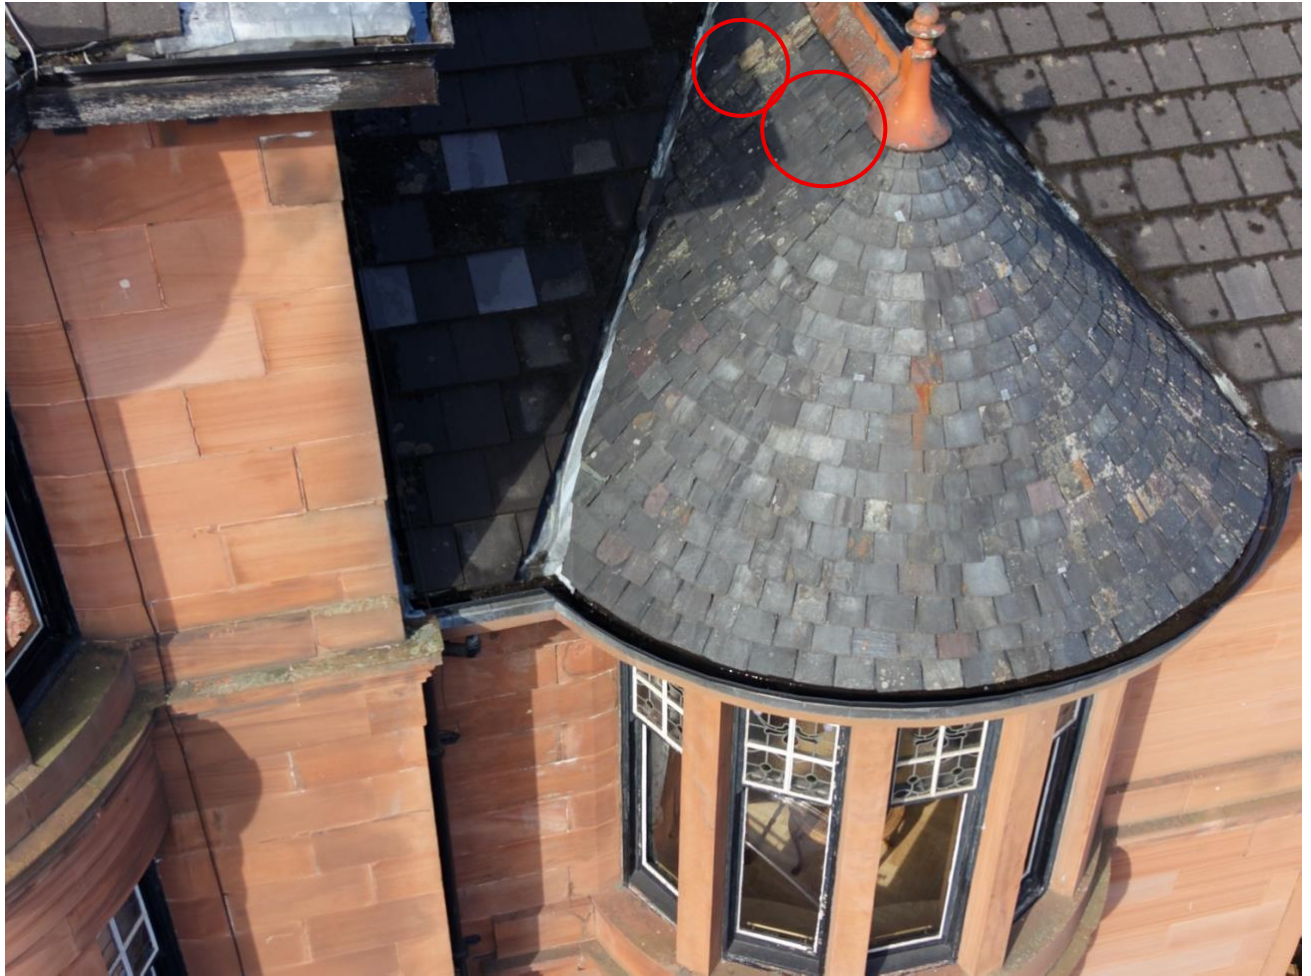
**Image 4 (Left bay window, left side)**  
Image shows at least 2 missing slates

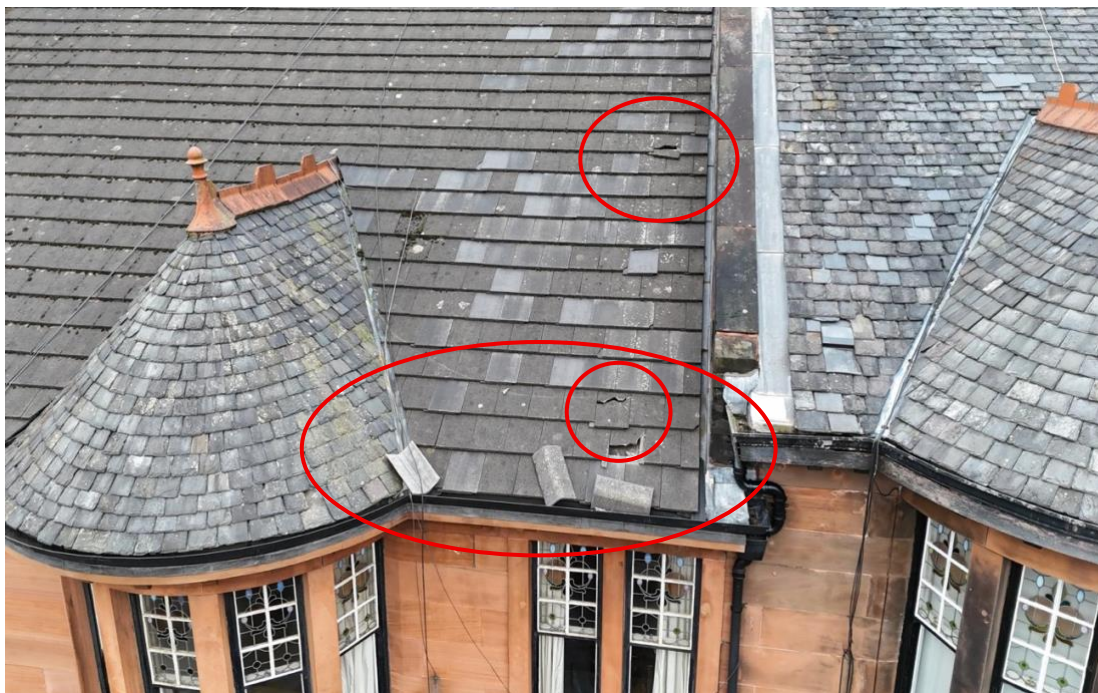
**Image 5**

Image shows broken and missing concrete tiles and ridge tiles which have cascaded down the roof towards the bay window and gutter. It is the professional opinion of the report writer that the falling of the ridge tiles to this area, along with storm force winds, are the likely cause of the damage to the concrete tiles as noted and damage could also have occurred to the slated bay window area.

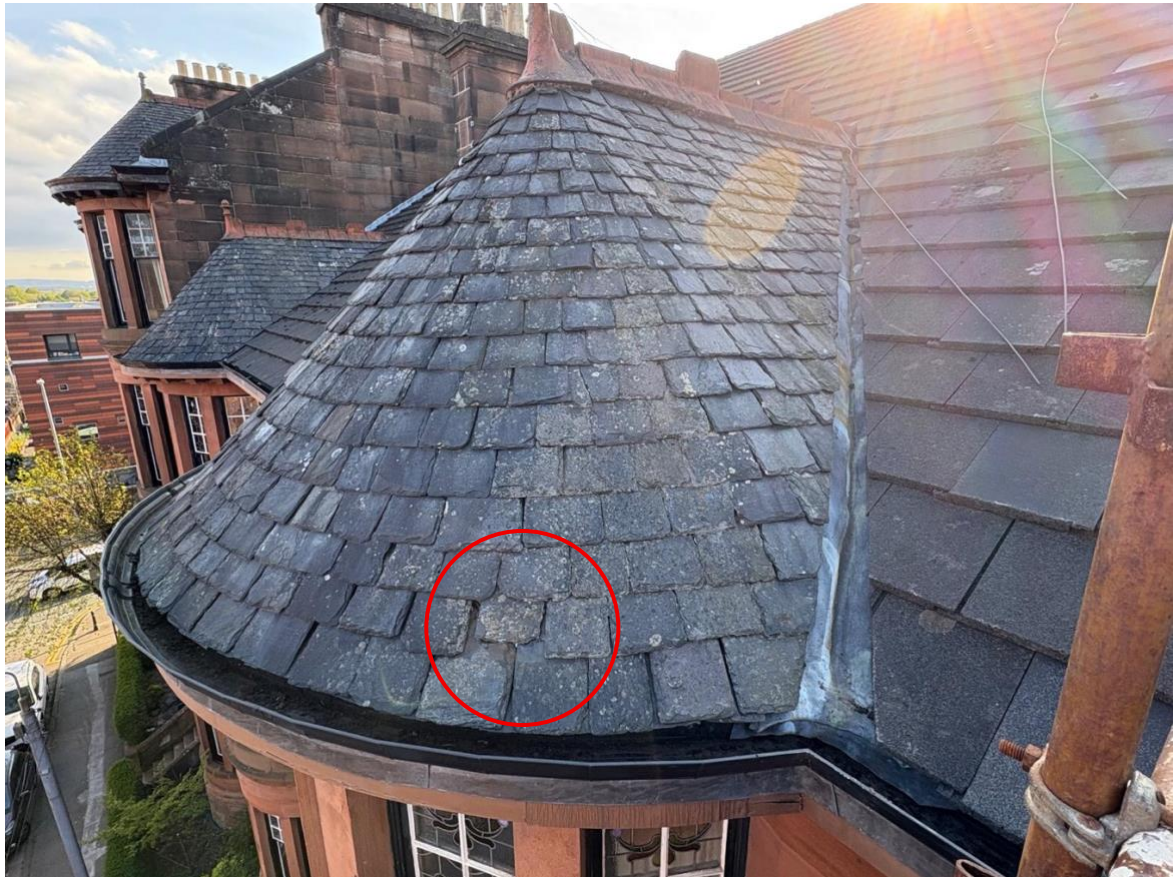
## Image 6

Image of the right side of the right bay window. Image shows a broken slate on the bay window.

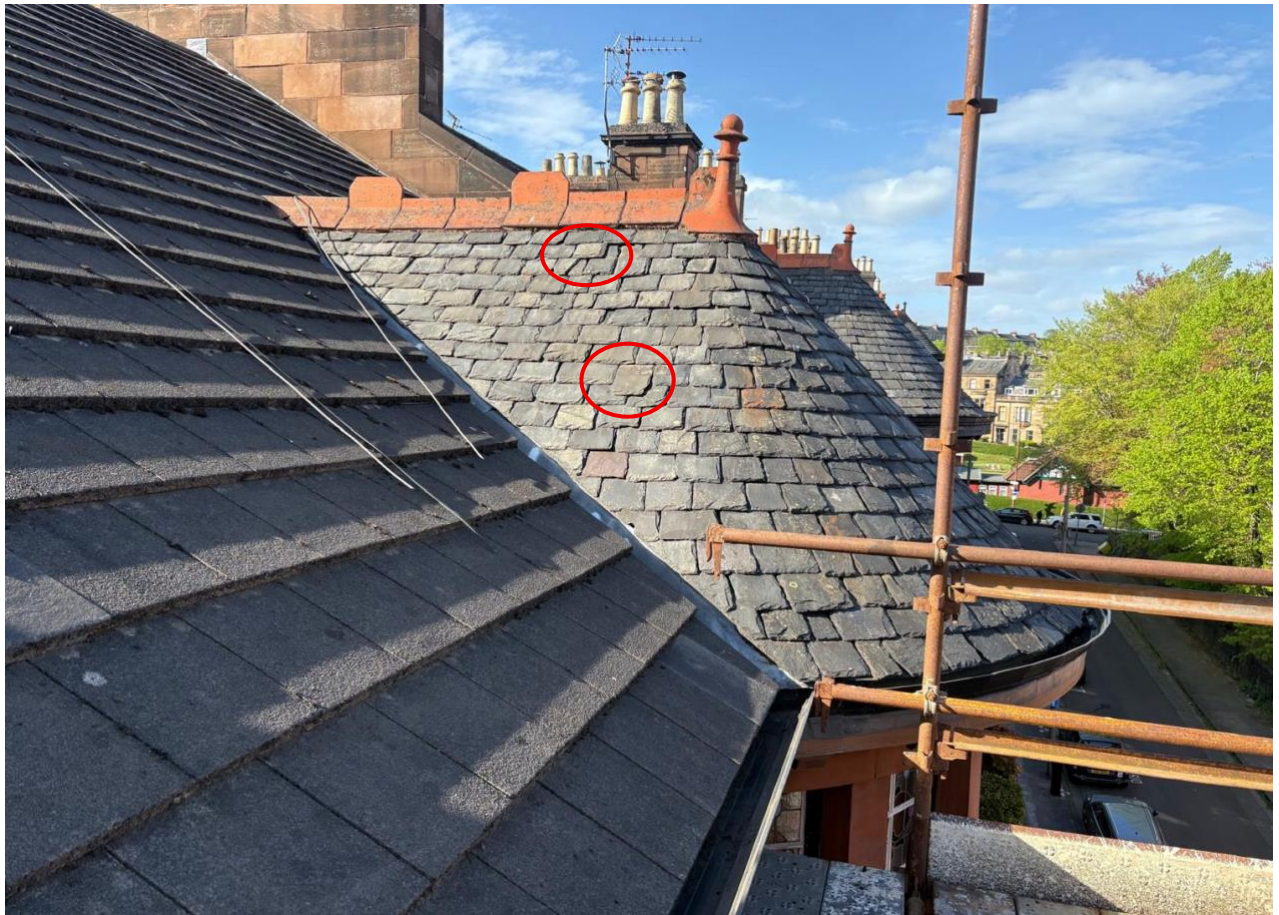
## Image 7

Image of left side of right bay window showing one missing (top) and one slipped  
slate (bottom)

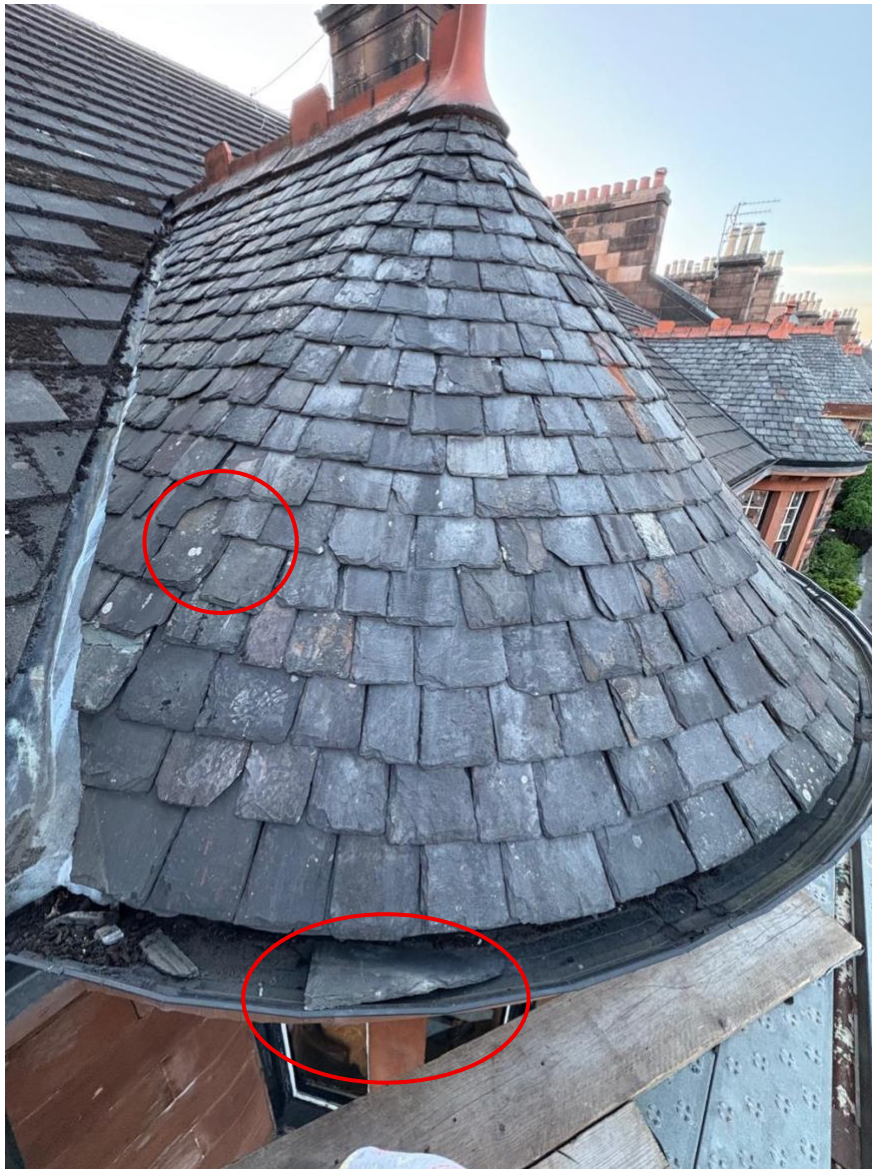
**Image 8**

Images of the left bay window left side which shows a broken slate.

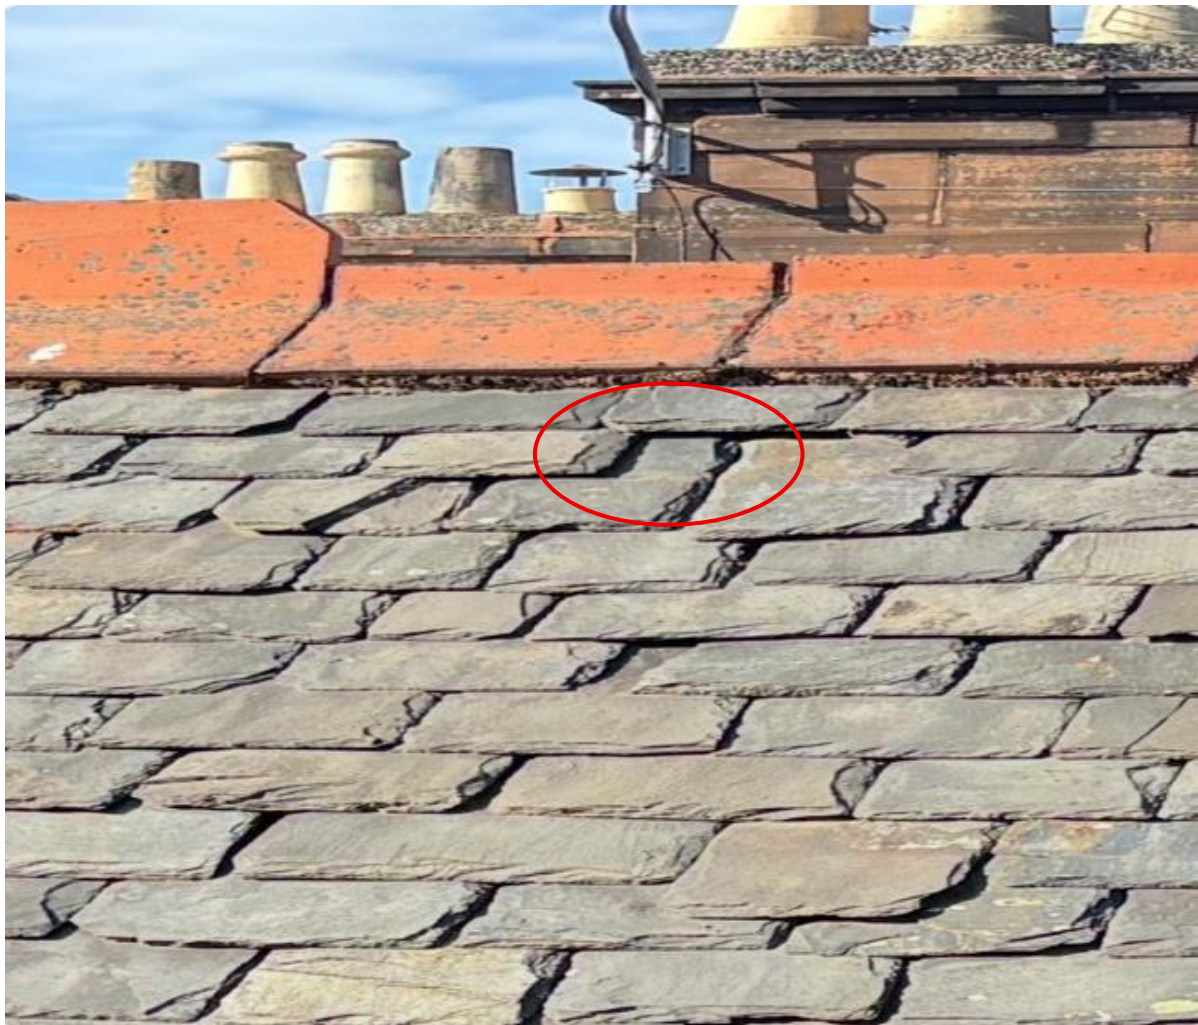
**Image 9**

Close up image of the left bay window, left side at ridge, showing 2 broken slates.
